<b>Make:</b> LDV	<b>Model:</b> G10	<b>Body Style:</b> Van
<b>Year:</b> 2017	<b>Registration:</b> KHU54	<b>Reg Expiry:</b> 08 Aug 2024
<b>WoF Expiry:</b> 09 Nov 2024	<b>Odometer:</b> 200,650 Kms	<b>Good No:</b> 22980807
<b>VIN:</b> LSKG4GL14GA425137	<b>Next Service:</b> 200000	<b>Service History:</b> No

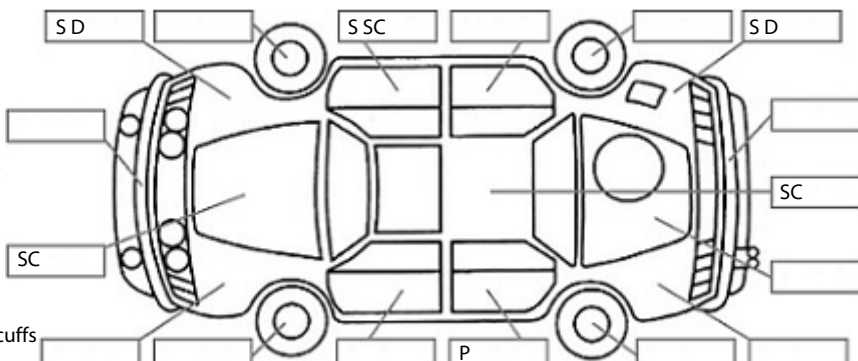
**Body Inspection Comments** Note: some defects & blemishes may not be displayed in the diagram

Right hand drivers side sill paint worn off, minor stonechips front windscreen, clear coat coming of both headlights, surface rust on both front door lower panels, x3 rear floor interior tether hooks have surface rust, surface rust along top of windscreen, lower front bumper grille loose,
