| Make: Mercedes-Benz | Model: GLA180 | Body Style: Hatchback |
| Year: 2015 | Registration: PMF395 | Reg Expiry: 20 Jan 2025 |
| VIN: WDC1569422J182776 | Next Service: | Service History: No |

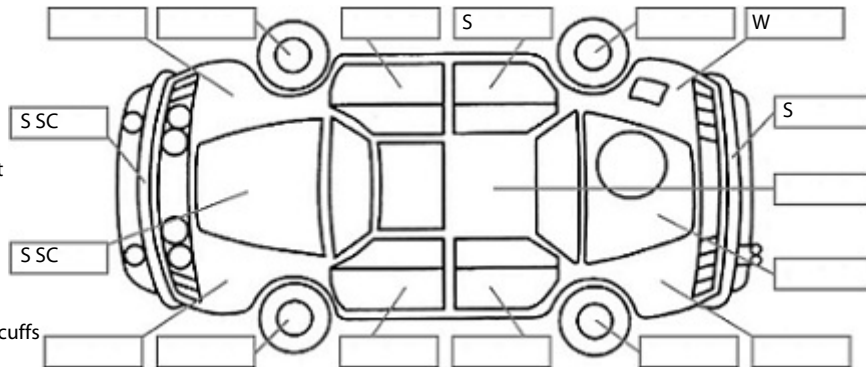
Body Inspection Comments

Note: some defects & blemishes may not be displayed in the diagram

Conditions During Body Inspection: Wet
