| Make: Toyota | Model: Hilux | Body Style: Utility |
| Year: 2018 | Registration: LEY497 | Reg Expiry: 25 Mar 2025 |

Body Inspection Comments

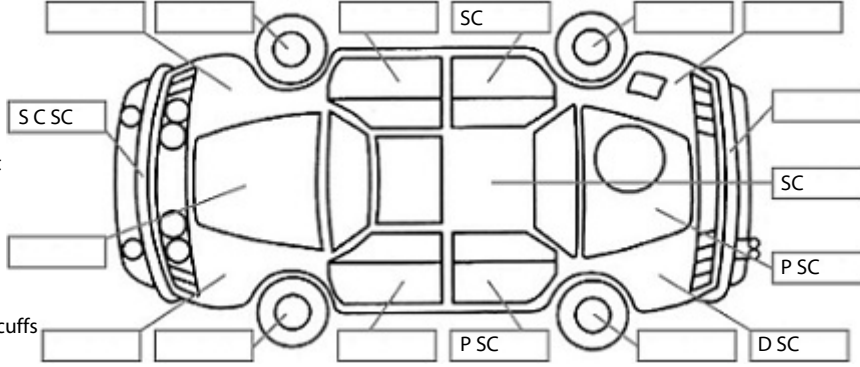
Note: some defects & blemishes may not be displayed in the diagram

- Aerial missing. Slight condensation in RH taillight.
- All weather strips damaged.
- RF sill step plate worn.
- RH running board bent.
