Make: Toyota	Model: Hiace 2.4ZR MAN	Body Style: Van
Year: 1993	Registration: RU4743	Reg Expiry: 01 Jan 2025
WoF Expiry: 08 Aug 2024	Odometer: 243,265 Kms	Good No: 25756977
VIN:	Next Service: 252,000kms	Service History: No

Body Inspection Comments

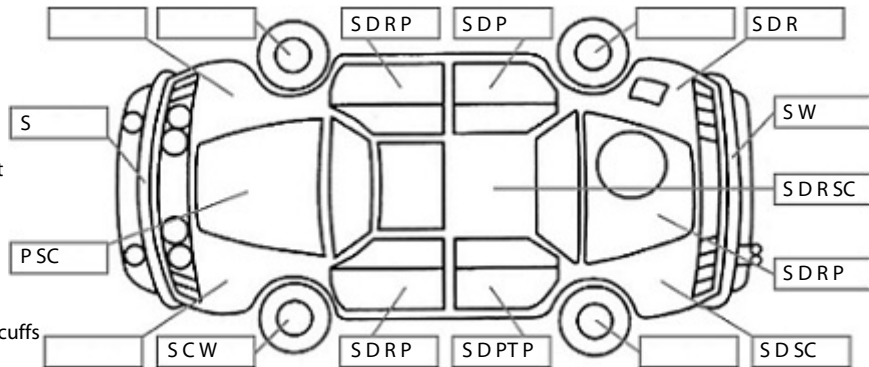
Plastic cover missing off left front wiper arm. Rust starting on bottom inside edge of left front door. Rust starting on right rear C pillar, on inside of tailgate door frame. Radio aerial is bent. Rust starting to bubble up under paint, at bottom of right front door. Missing left rear wheel hub cap
