<b>Make:</b> Toyota	<b>Model:</b> Hilux	<b>Body Style:</b> Utility
<b>Year:</b> 2011	<b>Registration:</b> FWL890	<b>Reg Expiry:</b> 10 Mar 2025
<b>WoF Expiry:</b> 27 Aug 2025	<b>Odometer:</b> 293,642 Kms	<b>Good No:</b> 26333799
<b>VIN:</b> MR0FZ22G501047932	<b>Next Service:</b> 296,500kms	<b>Service History:</b> No

**Body Inspection Comments**

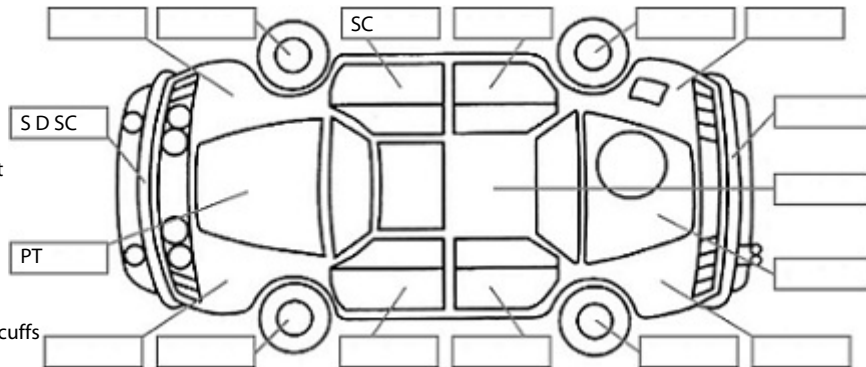
- Grille broken.
- Front guard liners damaged.
- Left rear mud guard damaged.
- Some body panels repainted, minor defects.
- Chipped windscreen.
- Step plates rusty.
- Drivers window & windscreen scratched.
