Conditions During Body Inspection:

Under Carriage & Under Bonnet Inspection Comments Rwd

10 Dec 2024 Date:

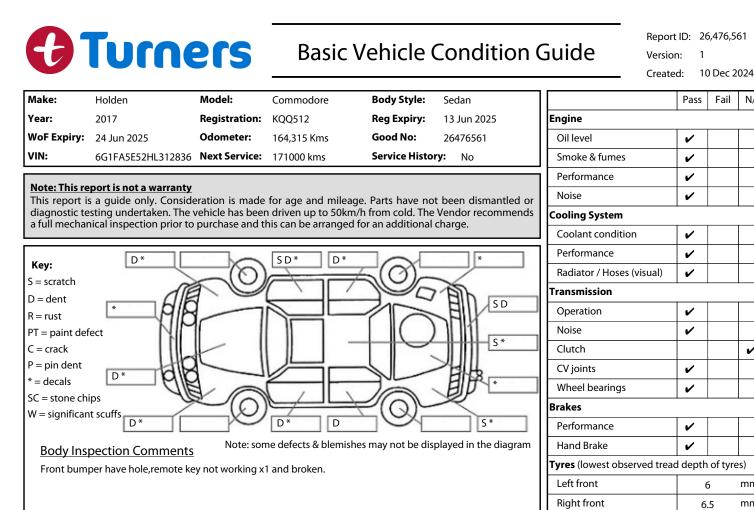
Police car lots of holes inside and missing plastic parts, , both front body seal torn,horn N/ working, steering worn, roof anttena hole, L rear body seal torn, driver seat adjustment not working, engine oil leak, L/ front lower arm bushes leaking, steering wheel button not working,
