Basic Vehicle Condition Guide

Report ID: 17,999,721
Version: 2
Created: 13 Aug 2024

Make:	Holden	**Model:**	Colorado	**Body Style:**	Utility
Year:	2019	**Registration:**	MDZ796	**Reg Expiry:**	17 Sep 2024
WoF Expiry:	30 Jun 2025	**Odometer:**	197,709 Kms	**Good No:**	17999721
VIN:	MMU148LK0LH60144	**Next Service:**	202,000kms	**Service History:**	No

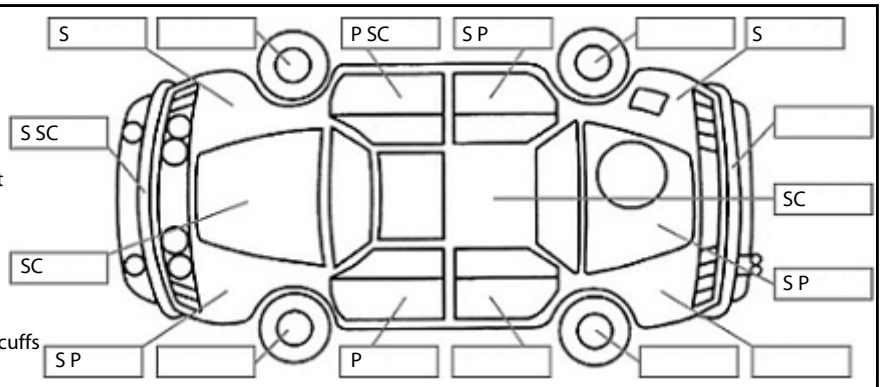
Bonnet stone guard is cracked.
Left shill paint flaking.
