# Basic Vehicle Condition Guide

Report ID: 22,939,357
Version: 1
Created: 11 Jul 2024

| **Make:** | Toyota | **Model:** | Altezza | **Body Style:** | Sedan |
| **Year:** | 1998 | **Registration:** | DSJ512 | **Reg Expiry:** | 19 May 2025 |

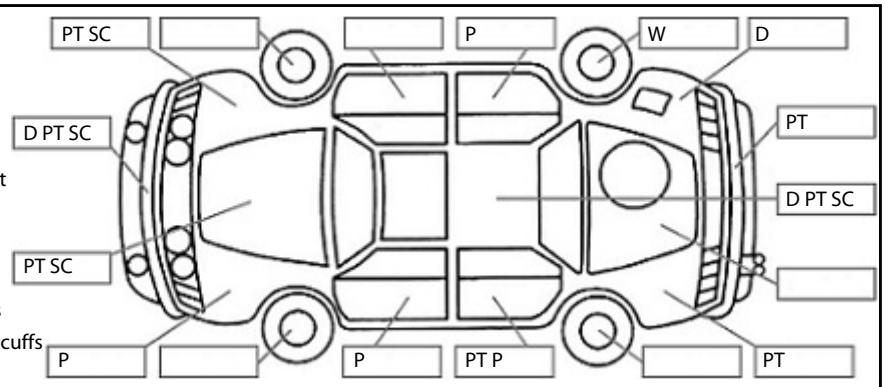
Note: some defects & blemishes may not be displayed in the diagram

L/R Taillight Cracked, From W/Screen cracked ,
