Basic Vehicle Condition Guide

Report ID: 23,021,496
Version: 2
Created: 15 Nov 2024

Make:	Mazda	**Model:**	323	**Body Style:**	Hatchback
Year:	1999	**Registration:**	XZ3529	**Reg Expiry:**	15 Mar 2025
WoF Expiry:	13 Nov 2024	**Odometer:**	117,323 Kms	**Good No:**	23021496
VIN:	JM0BJ10M100103810	**Next Service:**	120000km	**Service History:**	No

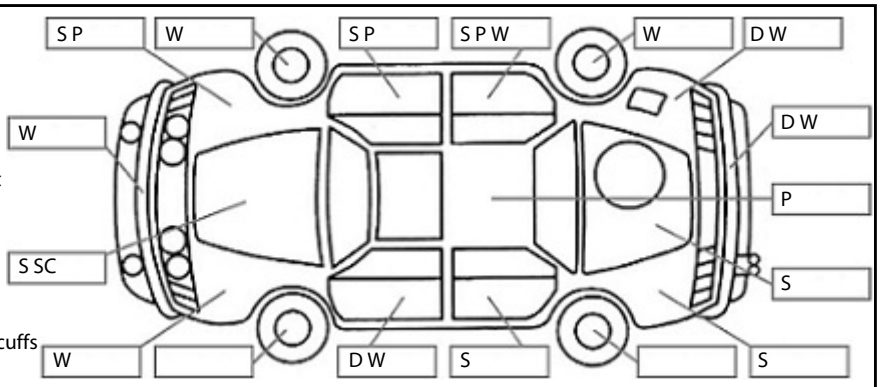
Dent in passengers side rocker panel.
Rust in Left rear window frame.
Surface rust starting in rest of window frames.
