# Turners

## Basic Vehicle Condition Guide

| **Make:** Honda | **Model:** CRV | **Body Style:** SUV |
| **Year:** 2008 | **Registration:** ERL478 | **Reg Expiry:** 11 Nov 2024 |

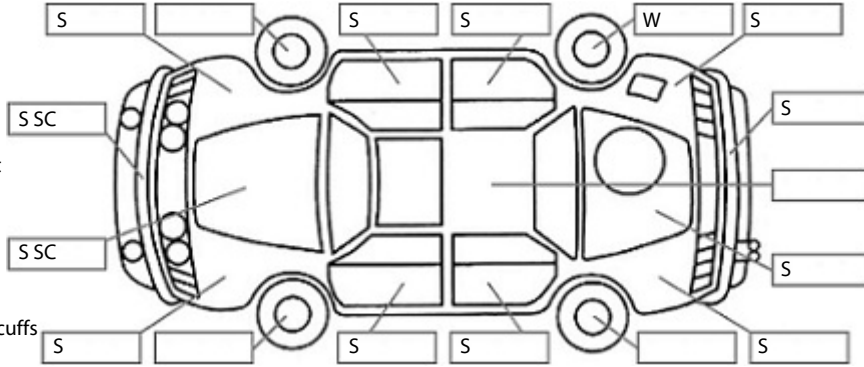
Note: some defects & blemishes may not be displayed in the diagram
