## Basic Vehicle Condition Guide

Report ID: 23,090,895
Version: 2
Created: 18 Oct 2024

| **Make:** BMW | **Model:** 3 Series | **Body Style:** Sedan |
| **Year:** 2005 | **Registration:** CUR828 | **Reg Expiry:** |

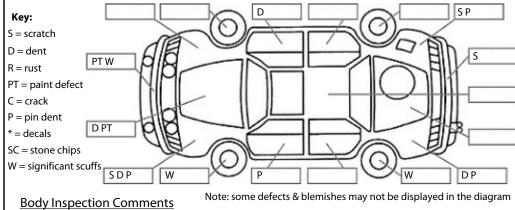
Diagram labels: D, S P, PT W, S, D PT, S D P, W, P, W, D P

Note: some defects & blemishes may not be displayed in the diagram
