## Basic Vehicle Condition Guide

Report ID: 25,089,451
Version: 1
Created: 14 Nov 2024

| **Make:** Mitsubishi | **Model:** Triton | **Body Style:** Utility | |
| **Year:** 2020 | **Registration:** MTR886 | **Reg Expiry:** 22 Mar 2025 | |

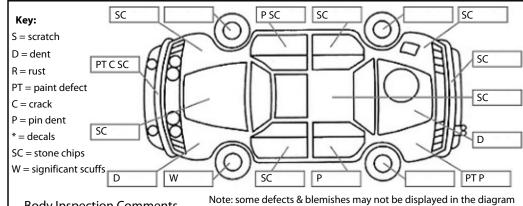
Diagram labels: SC, P SC, SC, SC, PT C SC, SC, SC, SC, D, W, SC, P, PT P, D

### Body Inspection Comments
Stone chips in windscreen, minor dents right cab corner
Right front step plate worn,
