# Basic Vehicle Condition Guide

Report ID: 25,571,493
Version: 2
Created: 09 Apr 2024

| **Make:** | Mazda | **Model:** | E2000 | **Body Style:** | Van |
| **Year:** | 2010 | **Registration:** | FHD320 | **Reg Expiry:** | 01 Sep 2024 |

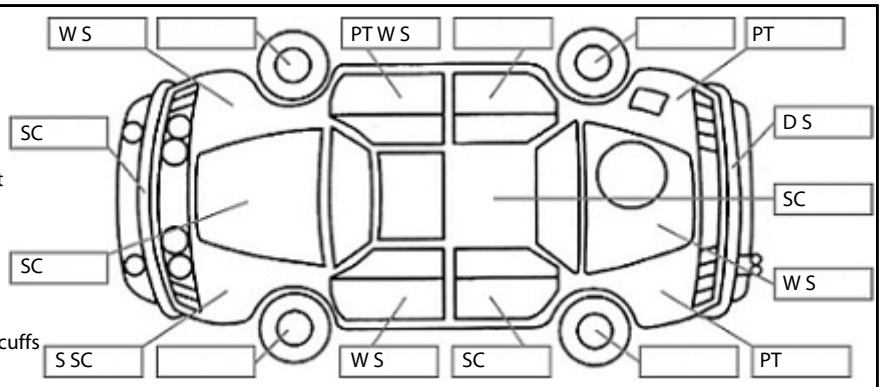
Note: some defects & blemishes may not be displayed in the diagram

Windscreen has stonechips. Vehicle has poor paint condition
