# Basic Vehicle Condition Guide

Report ID: 26,352,549
Version: 3
Created: 30 Oct 2024

| **Make:** | Subaru | **Model:** | Legacy | **Body Style:** | Wagon |
| **Year:** | 2009 | **Registration:** | HNC544 | **Reg Expiry:** | 12 Dec 2024 |

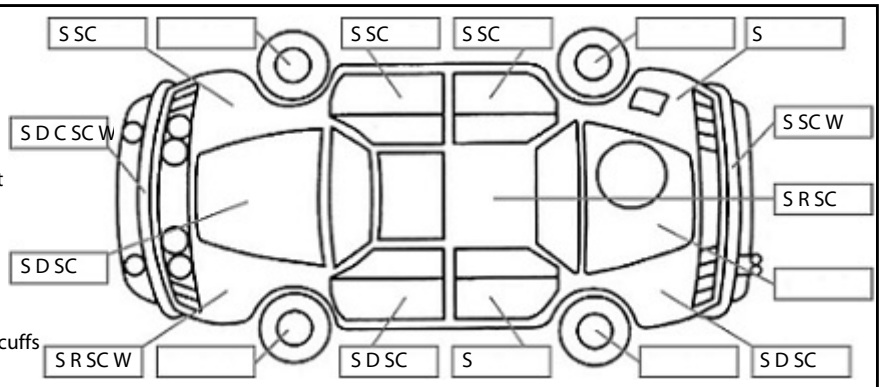
Note: some defects & blemishes may not be displayed in the diagram

Headlights are faded. Stone chips in front screen
