Basic Vehicle Condition Guide

Report ID: 26,363,179
Version: 1
Created: 21 Oct 2024

Make:	Subaru	**Model:**	Impreza	**Body Style:**	Hatchback
Year:	2008	**Registration:**	MFC862	**Reg Expiry:**	13 Dec 2024
WoF Expiry:	02 Nov 2024	**Odometer:**	163,059 Kms	**Good No:**	26363179
VIN:	7AT0GF09X19005471	**Next Service:**	172,000	**Service History:**	No

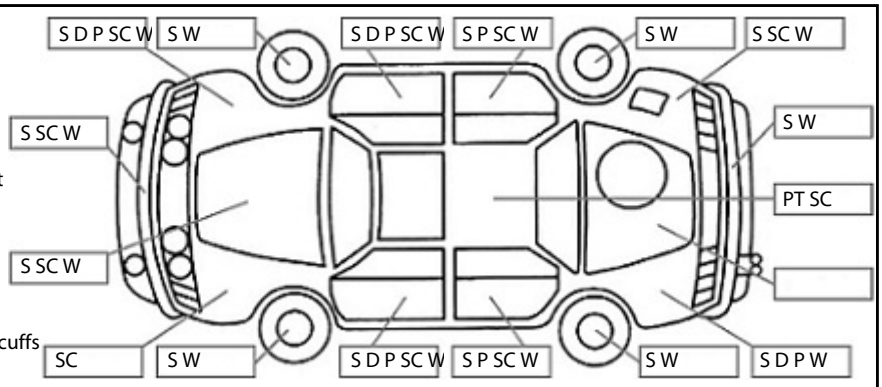
Front bumper different colour to vehicle, Headlamps cloudy, LH side skirt coming off, Structural dent in LH sill & "C" pillar, Paint faded on rear spoiler,
