Basic Vehicle Condition Guide

Report ID: 26,391,089
Version: 1
Created: 29 Oct 2024

Make:	Mazda	**Model:**	Verisa	**Body Style:**	Hatchback
Year:	2009	**Registration:**	KHA1	**Reg Expiry:**	03 Jul 2025
WoF Expiry:	18 Jan 2025	**Odometer:**	112,769 Kms	**Good No:**	26391089
VIN:	7AT0C103X16336860	**Next Service:**	115000	**Service History:**	No

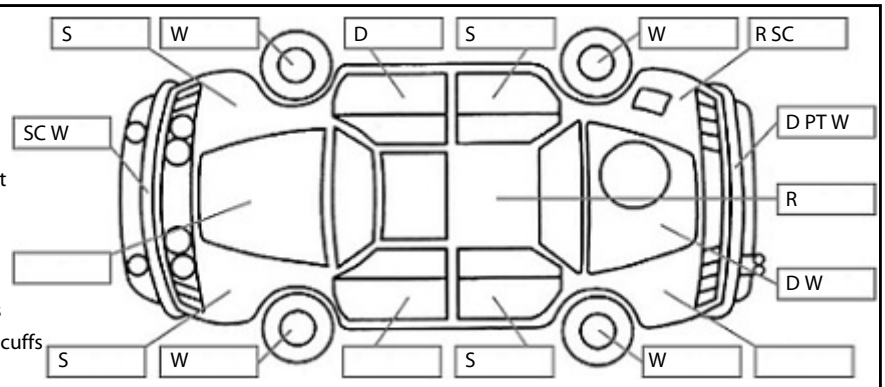
Note: some defects & blemishes may not be displayed in the diagram
