# Basic Vehicle Condition Guide

Report ID: 26,401,123
Version: 1
Created: 20 Nov 2024

| **Make:** | Nissan | **Model:** | Tiida | **Body Style:** | Sedan |
| **Year:** | 2012 | **Registration:** | NMM790 | **Reg Expiry:** | 16 Nov 2024 |

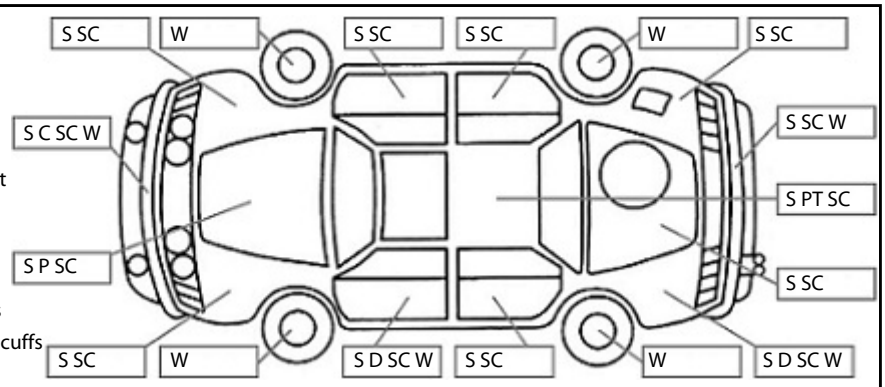
Note: some defects & blemishes may not be displayed in the diagram

Stone chips front window screen
Broken left tail light
