Basic Vehicle Condition Guide

Report ID: 26,423,715
Version: 1
Created: 25 Nov 2024

Make:	Toyota	**Model:**	Landcruiser Prado	**Body Style:**	Wagon
Year:	1996	**Registration:**	ZL8890	**Reg Expiry:**	04 Feb 2025
WoF Expiry:	30 Jan 2025	**Odometer:**	406,609 Kms	**Good No:**	26423715
VIN:	7A8H60H0700025415	**Next Service:**	overdue	**Service History:**	Yes

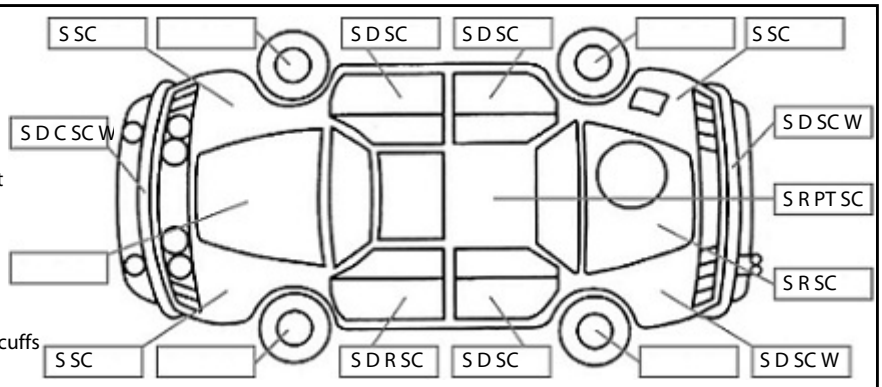
No check strap drivers door. Centre arm rest broken. Rhr window broken and wedged, lhr very slow. Rear door hinges worn. Stone chips in front screen. Stone chips in headlights
