## Basic Vehicle Condition Guide

Report ID: 26,461,235
Version: 4
Created: 12 Dec 2024

| **Make:** Toyota | **Model:** Hiace | **Body Style:** Van |
| **Year:** 2009 | **Registration:** LPF713 | **Reg Expiry:** 12 Feb 2025 |

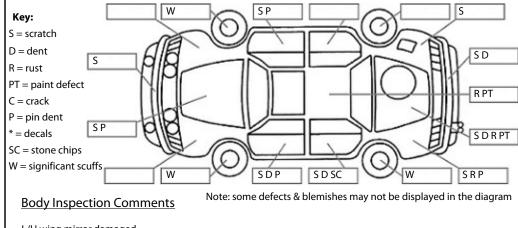
Diagram labels: W, S P, S, S, S D, R PT, S D R PT, S P, S P, W, S D P, S D SC, W, S R P

L/H wing mirror damaged.
Tail lights scratched&cracked.
