# Basic Vehicle Condition Guide

Report ID: 26,479,148
Version: 3
Created: 12 Dec 2024

| **Make:** | Mitsubishi | **Model:** | Outlander | **Body Style:** | Wagon |
| **Year:** | 2005 | **Registration:** | KJQ932 | **Reg Expiry:** | 04 Aug 2025 |

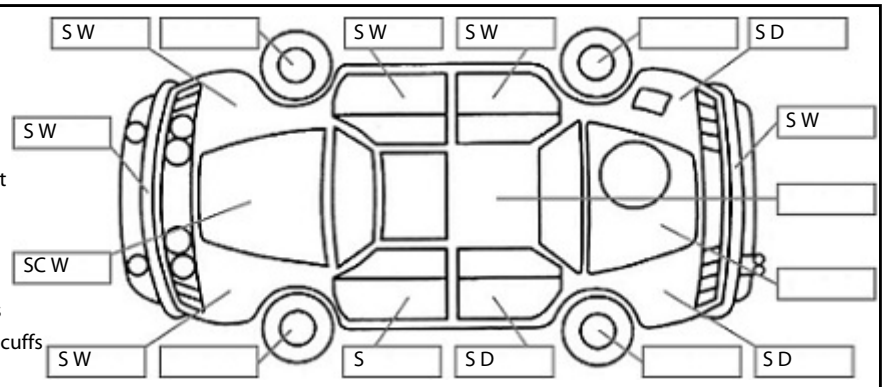
Note: some defects & blemishes may not be displayed in the diagram

Windscreen broken
Front bumper insecure
