| Make: Mazda | Model: Mazda2 | Body Style: Hatchback |
| Year: 2018 | Registration: LQR897 | Reg Expiry: 17 Dec 2024 |
| VIN: MM0DJ2HAA0W40051 | Next Service: 80,163kms | Service History: No |

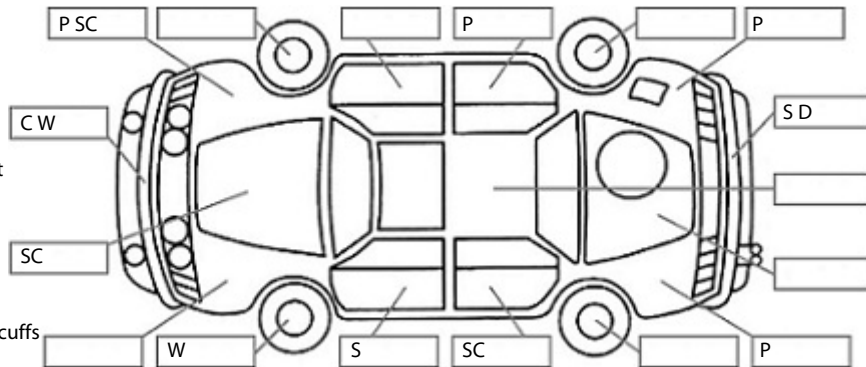
Body Inspection Comments

Note: some defects & blemishes may not be displayed in the diagram

- Tail gate badge (Mazda2) removed, secured in handbook.
- Right front door seal is torn.
- Cargo area left trim, parcel tray fitting pin is broken and missing.
- Rear wiper blade is worn, torn.
