<b>Make:</b>	Mitsubishi	<b>Model:</b>	Pajero Sport	<b>Body Style:</b>	SUV
<b>Year:</b>	2020	<b>Registration:</b>	MTH35	<b>Reg Expiry:</b>	18 Nov 2024
<b>WoF Expiry:</b>	13 May 2025	<b>Odometer:</b>	119,326 Kms	<b>Good No:</b>	23034696
<b>VIN:</b>	MMAGUKS10LH00203	<b>Next Service:</b>	130,000	<b>Service History:</b>	Yes

**Body Inspection Comments**

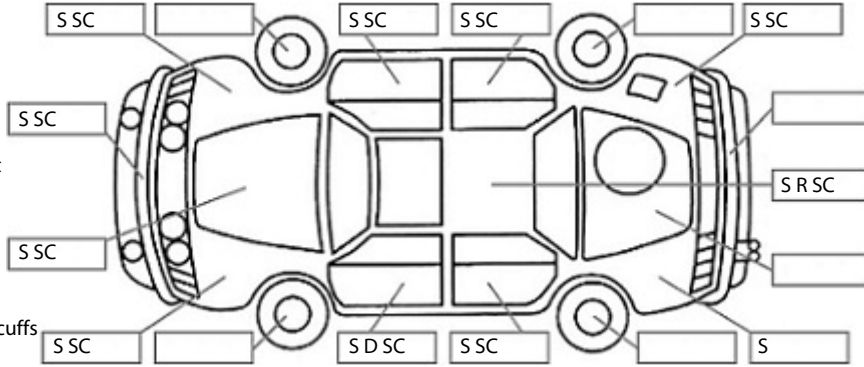
Note: some defects & blemishes may not be displayed in the diagram

Drivers mirror casings broken. Centre lhs head rest missing. Front bumper lower skirt broken and held in place with cable ties. Rear badge damaged. Vehicle very dirty at inspection time. Stone chips in front screen
