<b>Make:</b> Holden	<b>Model:</b> Commodore	<b>Body Style:</b> Sedan
<b>Year:</b> 2019	<b>Registration:</b> MAF869	<b>Reg Expiry:</b> 06 Mar 2025
<b>WoF Expiry:</b> 05 Mar 2025	<b>Odometer:</b> 246,168 Kms	<b>Good No:</b> 24953263
<b>VIN:</b> W0VZM6ECXK102071	<b>Next Service:</b> 261,000kms	<b>Service History:</b> No

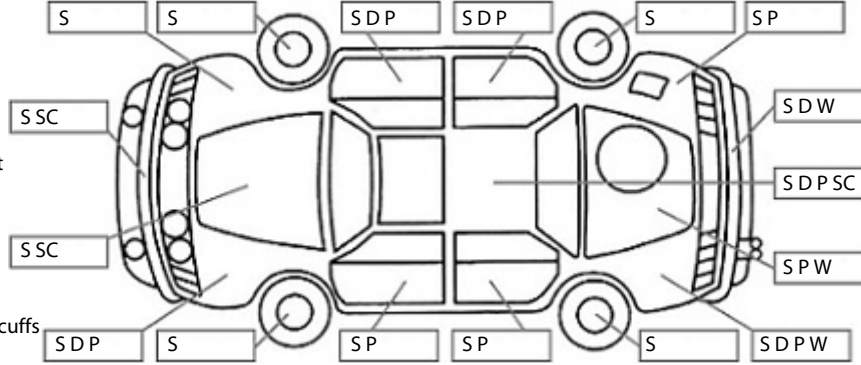
Small stone crack in middle of windscreen. Holes in both front corners of front bumper & two holes in both rear corners of rear bumper. Holes in interior trim on rear tailgate. Two R/T aerial base fitted to roof panel.
