Make: Holden	Model: Commodore	Body Style: Sedan
Year: 2019	Registration: MCD415	Reg Expiry: 15 Apr 2025
WoF Expiry: 16 Apr 2025	Odometer: 252,579 Kms	Good No: 24955000
VIN: W0VZM6ECXK1033740	Next Service: ?	Service History: Yes

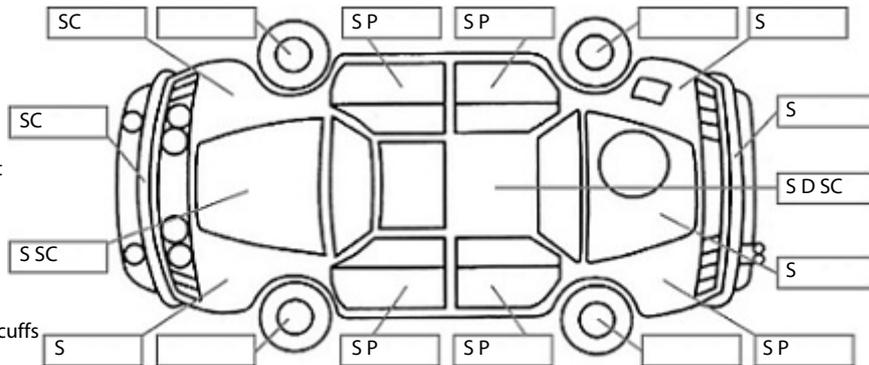
Body Inspection Comments

Holes in all corners of front & rear bumpers. Two R/T aerial bases fitted to roof panel. Left side of front grille is cracked with a large hole in it. Left side of front bumper is not clipping upto guard correctly. Spare tyre is under inflated to fit in spare wheel well. Large dent in left rear sill
