| Make: Toyota | Model: Hilux | Body Style: Utility |
| Year: 2019 | Registration: MHS234 | Reg Expiry: 24 Sep 2024 |
| VIN: MR0KA3CD50122823 | Next Service: 70,000 kms | Service History: No |

Body Inspection Comments

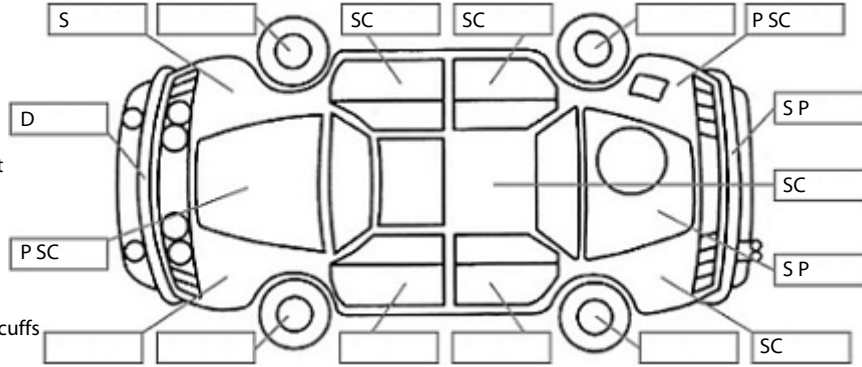
Centre caps missing from all wheels, dents and gouge left running board
Canopy door needs refitted, right front step plate worn
