<b>Make:</b> Ford	<b>Model:</b> Transit	<b>Body Style:</b> Van
<b>Year:</b> 2015	<b>Registration:</b> JBJ843	<b>Reg Expiry:</b> 14 Jan 2025
<b>WoF Expiry:</b> 16 Jun 2025	<b>Odometer:</b> 159,008 Kms	<b>Good No:</b> 25052929
<b>VIN:</b> WF0XXXTTGXEM4847	<b>Next Service:</b> 187,000kms	<b>Service History:</b> No

**Body Inspection Comments**

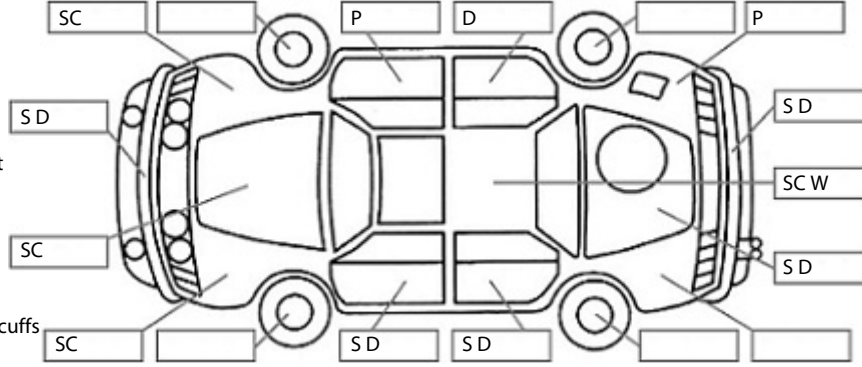
Fuel flap damaged. L/R door frame cracked. L/H cant rail damaged.  
R/H tail light chipped. R/H wing mirror not retracting.  
L/R door seal missing. Chipped windscreen.  
L/H wing mirror indicator lens cracked. High stop light cracked.

L/R door step, sill, frame & floor damaged.  
L/H plastic sill moulding damaged.  
6 speed manual diesel LWB high roof van.
