| Make: Toyota | Model: Hilux | Body Style: Utility |
| Year: 2019 | Registration: MPS925 | Reg Expiry: 16 Dec 2024 |

Body Inspection Comments

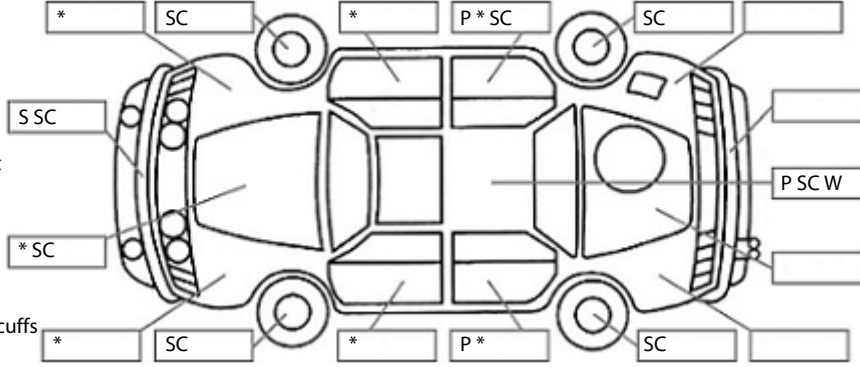
Note: some defects & blemishes may not be displayed in the diagram

Stone chip in windscreen.
Right sill panel is worn.
Drivers door seal is torn.
