| Make: Hyundai | Model: I30 | Body Style: Hatchback |
| Year: 2009 | Registration: GEF176 | Reg Expiry: 22 Jul 2024 |
| VIN: KMHDB51DR9U16530 | Next Service: | Service History: No |

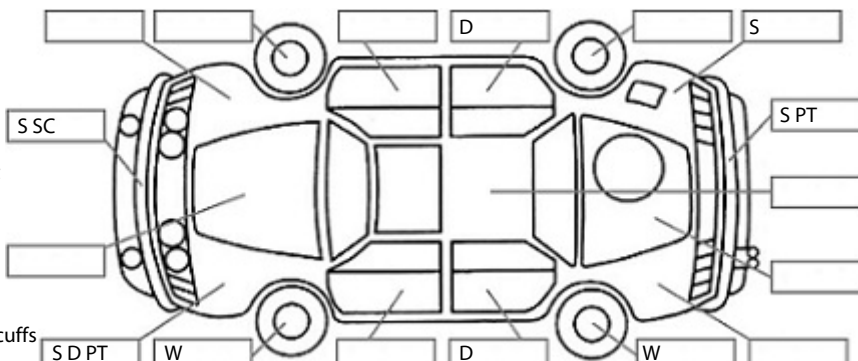
Body Inspection Comments
 Left wing mirror cover scratched.

Note: some defects & blemishes may not be displayed in the diagram
