## **Basic Vehicle Condition Guide**

Make: Model: Toyota Hilux **Body Style:** Utility Year: 2018 Registration: LGB428 **Reg Expiry:** 19 Mar 2025 WoF Expiry: **Odometer:** 07 May 2025 132,094 Kms **Good No:** 26381154 VIN: MR0KA3CD101205862 Next Service: 133,215kms **Service History:**

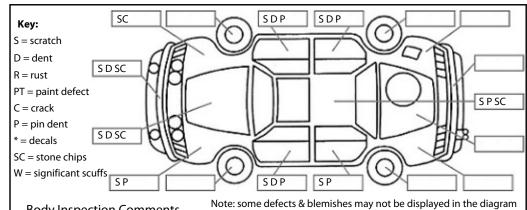
Large dent in drivers door panel. Paint worn through to metal on top of right side sill, under drivers door. Both left & right side running boards are bent.
