| Make: Nissan | Model: Bluebird | Body Style: Sedan |
| Year: 2005 | Registration: HLS959 | Reg Expiry: 01 May 2025 |
| VIN: 7AT0DH1EX14185690 | Next Service: 136,186kms | Service History: Yes |

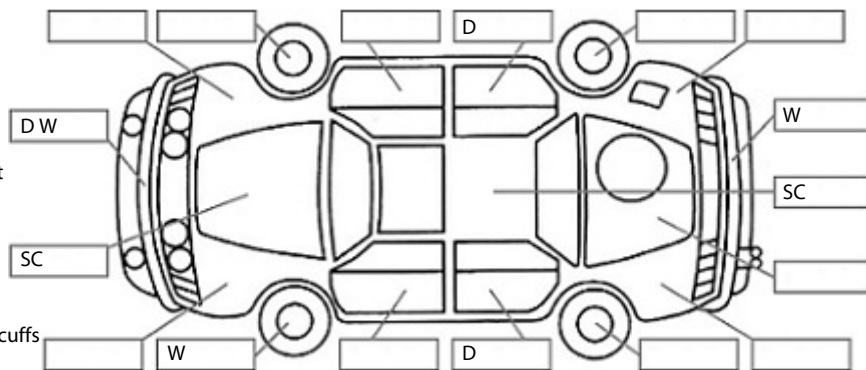
Body Inspection Comments

Note: some defects & blemishes may not be displayed in the diagram

Left front monsoon visor is broken.
Can not release shift from parking without using shift lock release button.
